SEGA OF AMERICA, INC.  
Consumer Products Division

# **32X Technical Information**

Doc. # MAR-41-R8-090694

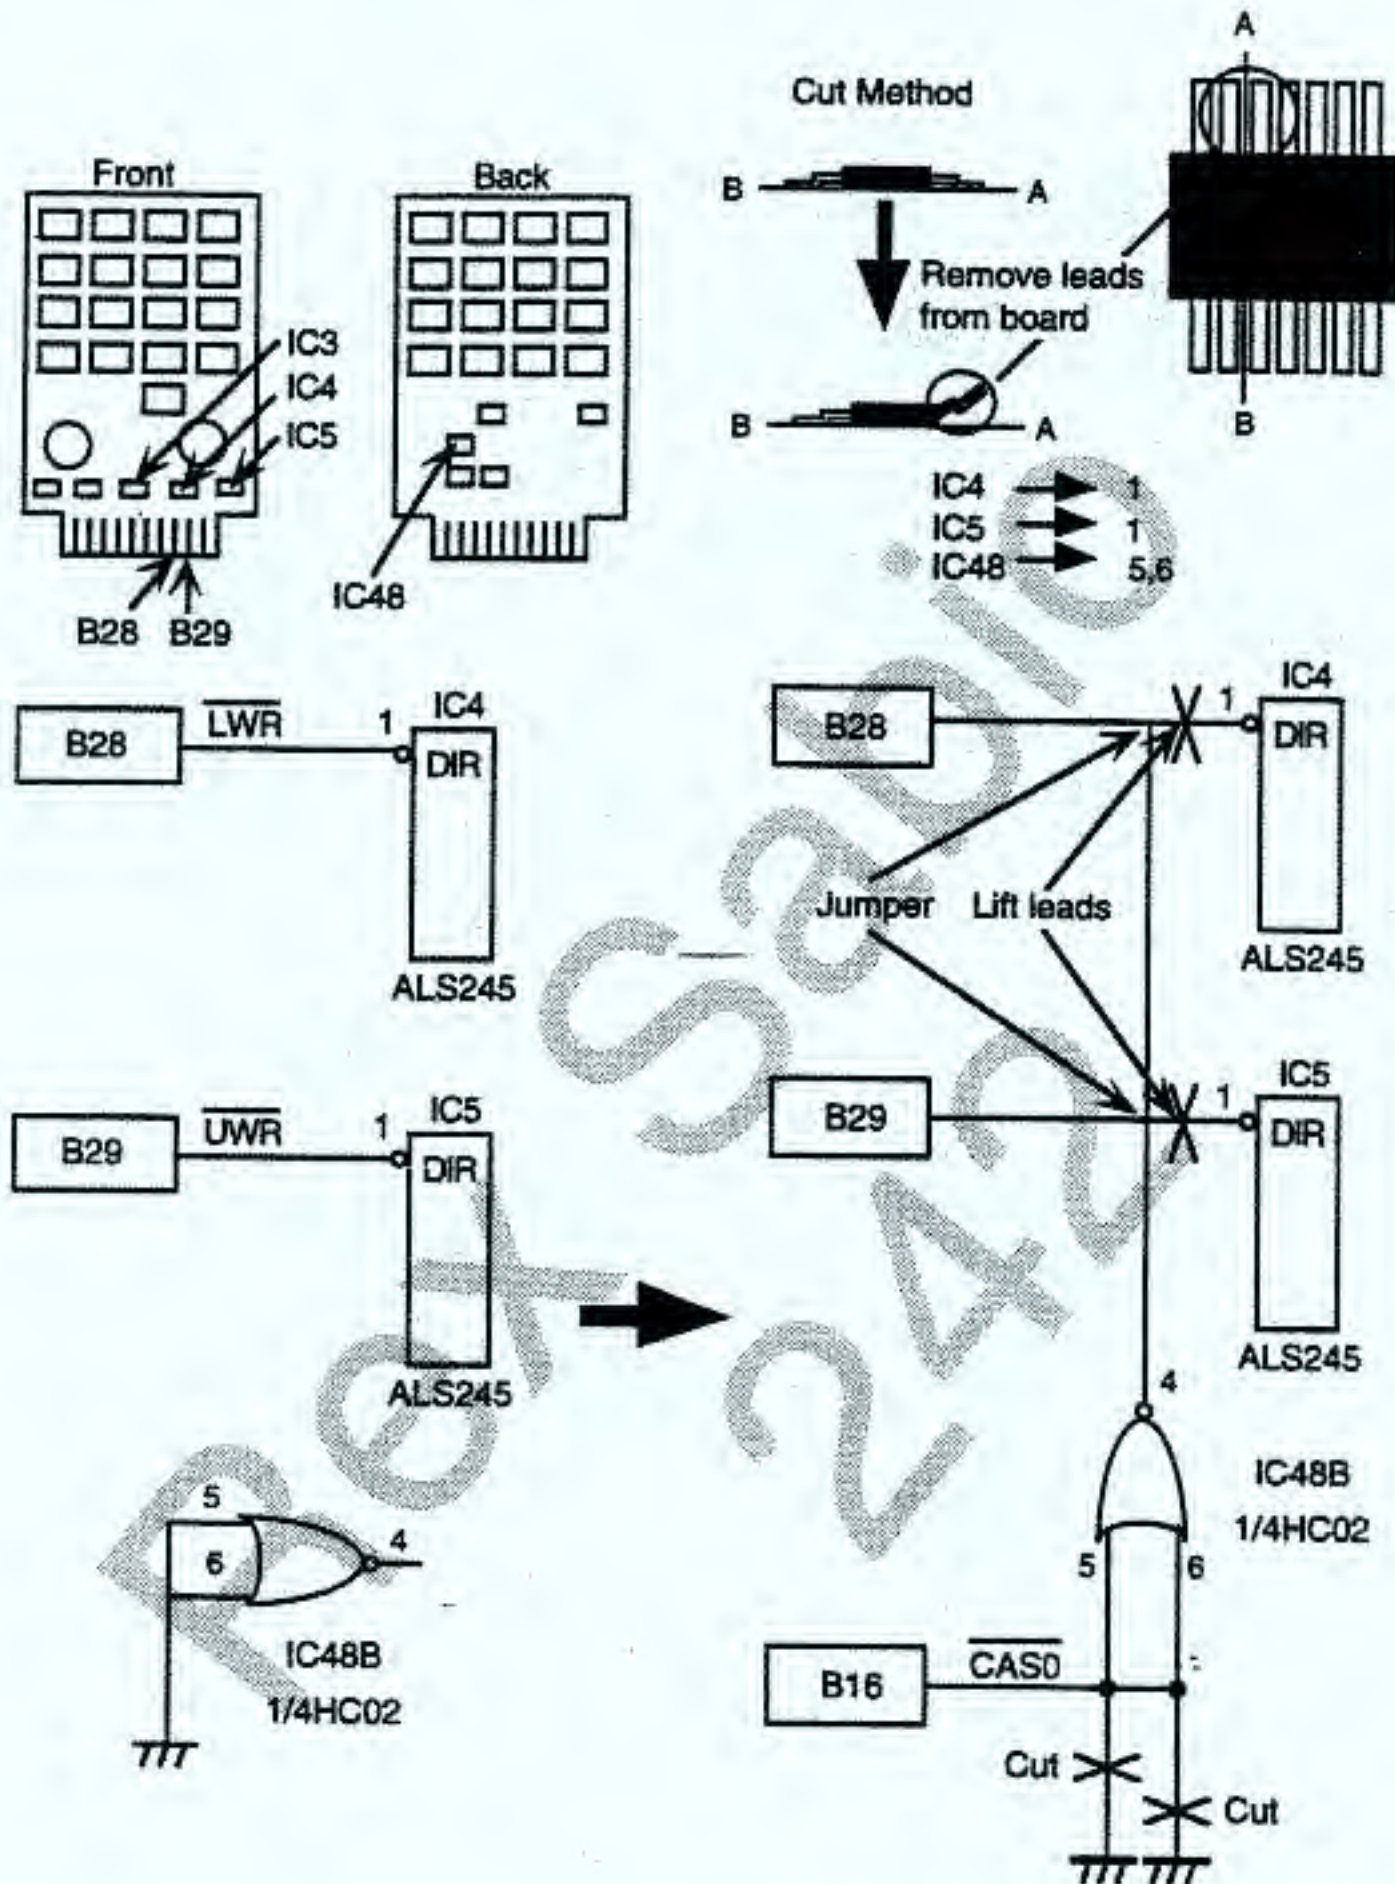
- The following modifications are necessary when a Mega Drive 32 Mbit SRAM board is used with the 32X.

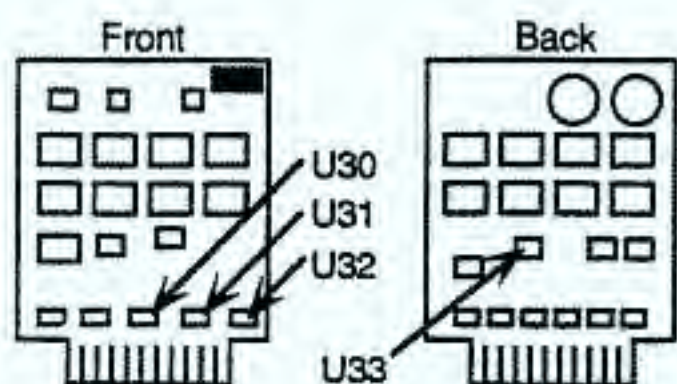
- The following modifications are necessary when a Mega Drive 16 Mbit SRAM board is used with the 32X.

- Lift no. 1 pins of U31 and U32.
- Similarly, lift no. 13, 14, and 15 pins of U33.
- Jump the no. 16 pin of U30 and the no. 13 and 14 pins of U33.
- Connect the no. 15 pin of U33 to the GND (no. 8 pin).
- Jump the no. 9 pin of U33 to each no. 1 pin of U31 and U32.

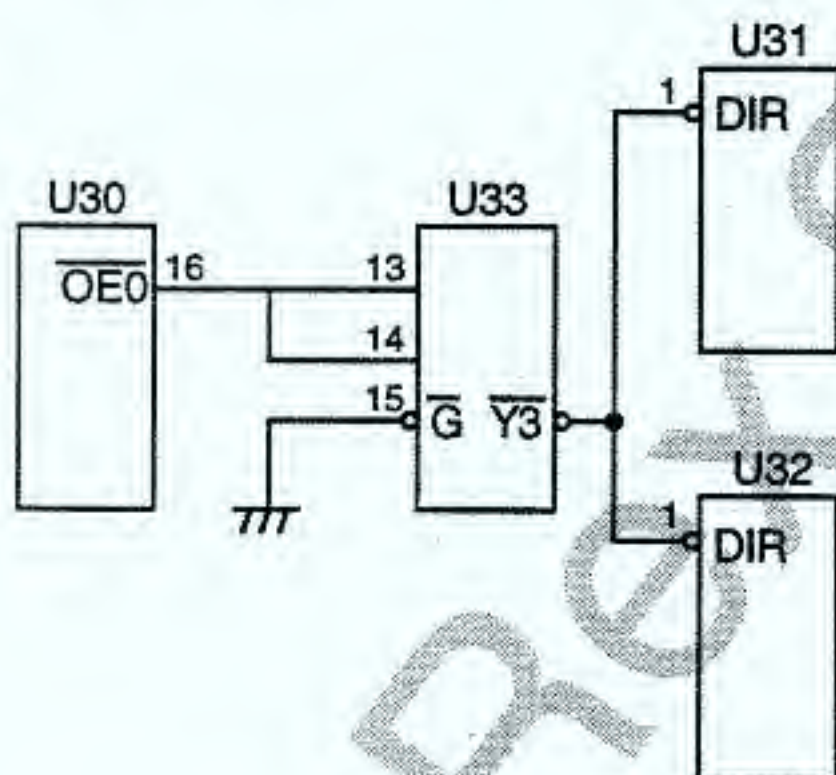
#### After Modification

Operation cannot be guaranteed if U31 and U32 are not AC or ALS type.  
If equipped with the LS type, the AC or ALS type should be attached, replacing the LS type.

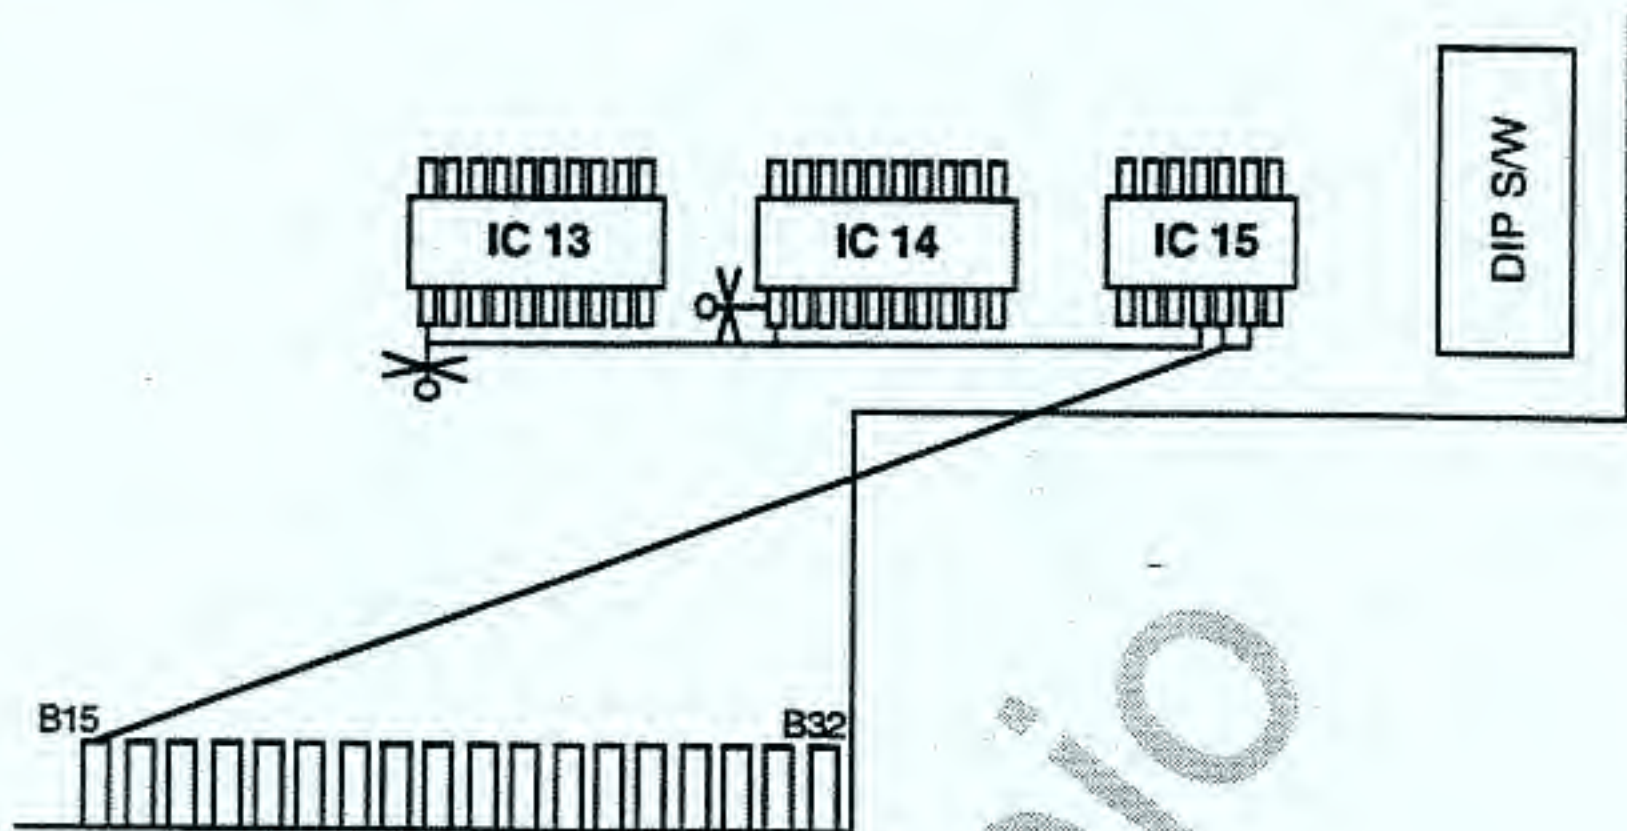
- The following modifications are necessary when a Mega Drive 32 Mbit ROM board is used with the 32X.

- Cut between the pattern of the IC13 no.1 pin and the through-hole below the pin.
- Cut between the pattern of the IC14 no.1 pin and the through-hole to the left of the pin.

- Cut the trace pattern of the IC 15 no.5 and no.6 pins.
- Wire (connect) IC13 no.1 pin, IC14 no.1 pin, and IC15 no.4 pin.
- Wire (connect) th IC 15 no.5 and no.6 pins to B16 of the card edge.
